# Test Report

Service Item : 日照計累積照度比對英文測試報告

Sample name : Pyranometer

Lab. name: Photovoltaics System Testing Laboratory

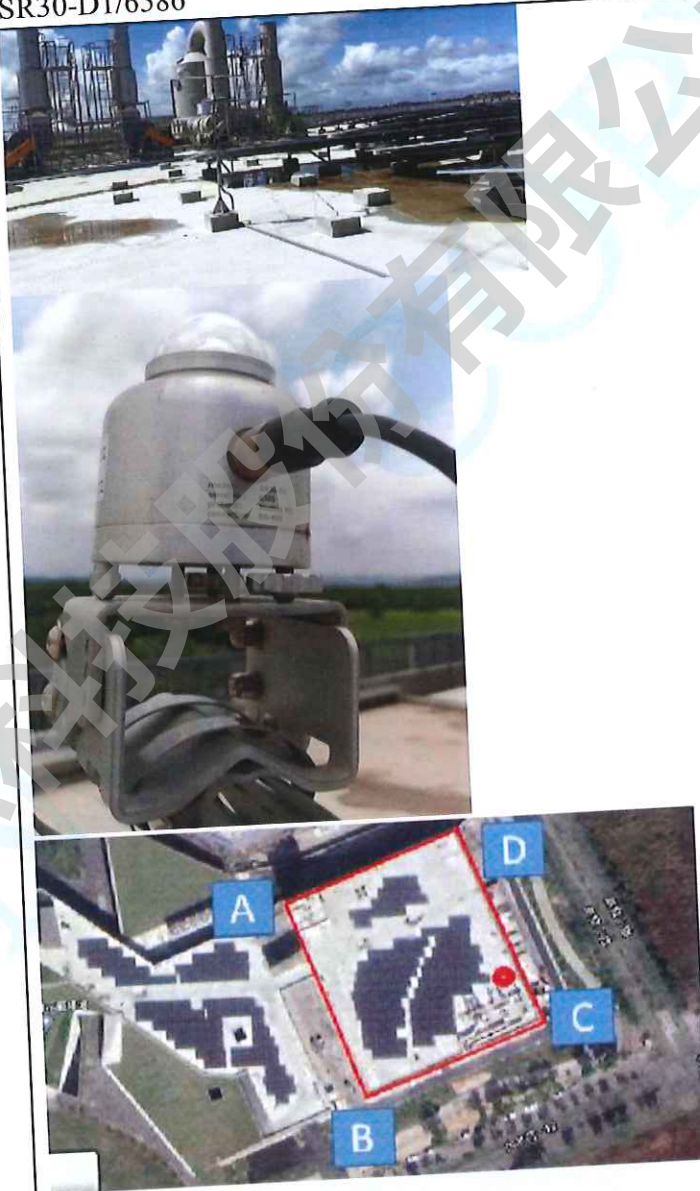
| Table A | | |
|---|---|---|
| Sensor locations | | |

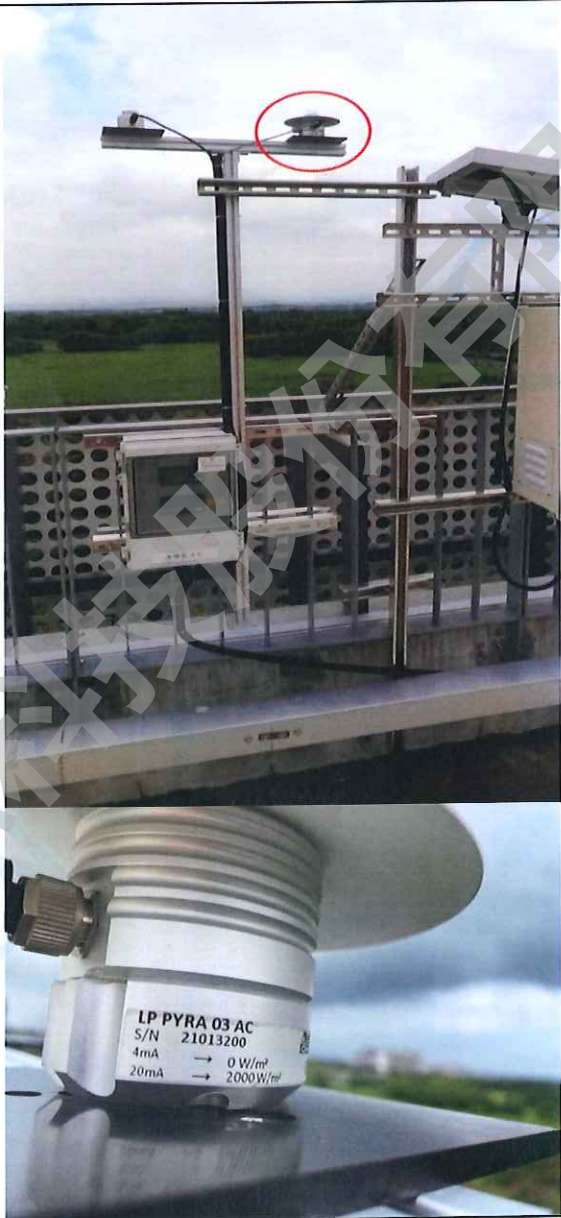
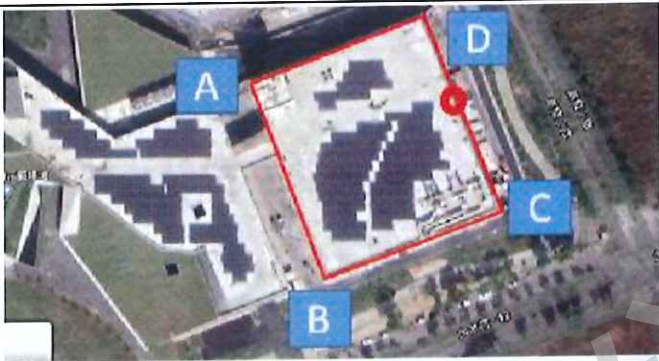
| Table B | |
|---|---|
| Sensor locations | |

| | Pyranometer at the red circle | |

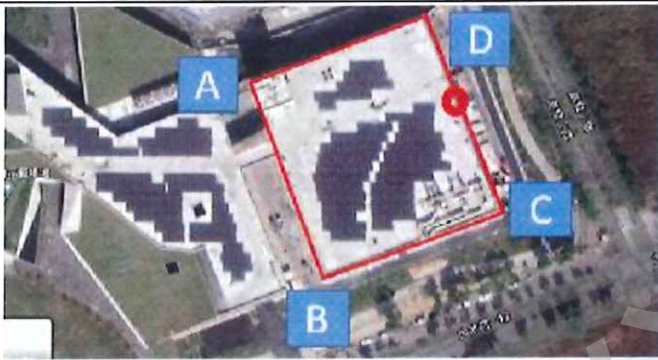
| Table C | |
|---|---|
| Sensor locations | |

| | Pyranometer at the red circle | |
