# Test Report

Report No. : 11055C01031-2-5-02

Service Item : 日照計累積照度比對英文測試報告

Sample name : Pyranometer

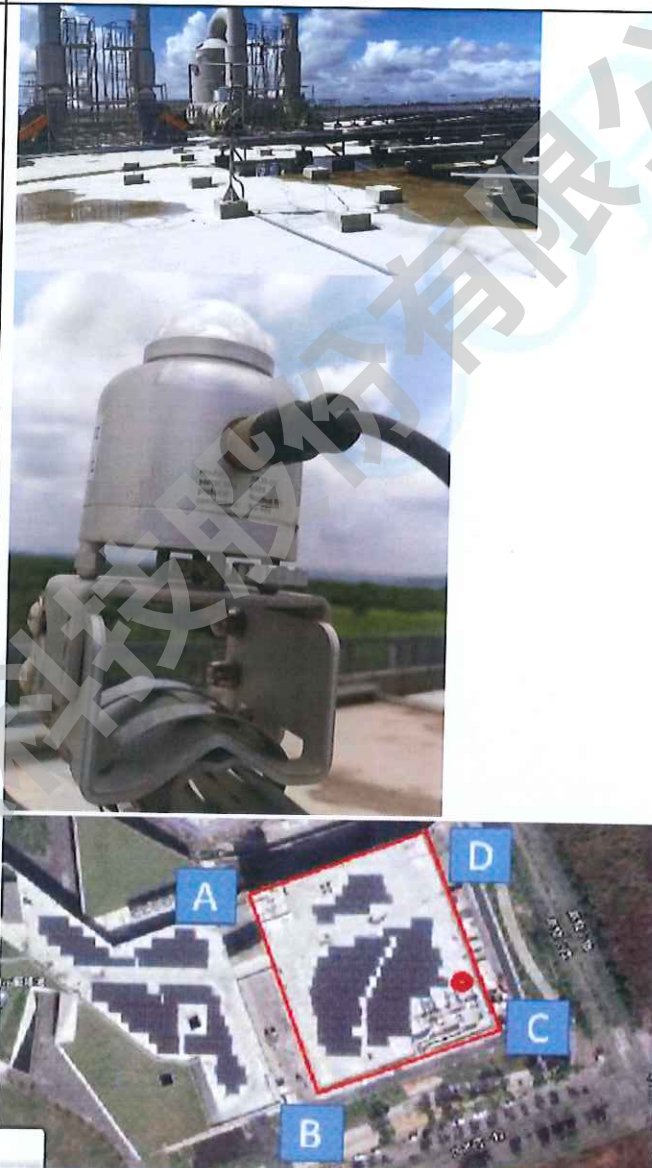
| Table A | | |
|---|---|---|
| Sensor locations | | |
| | Pyranometer at the red circle | |

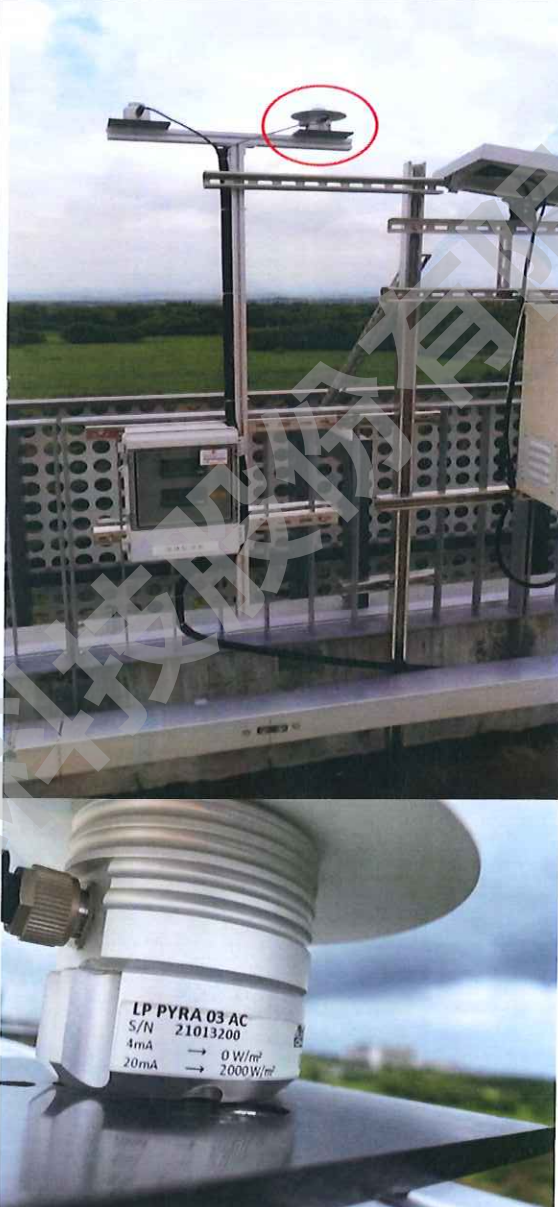
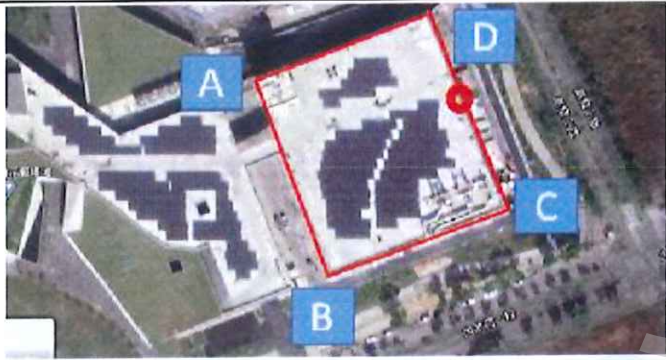
| Table B | |
|---|---|
| Sensor locations | |

| | Pyranometer at the red circle | |

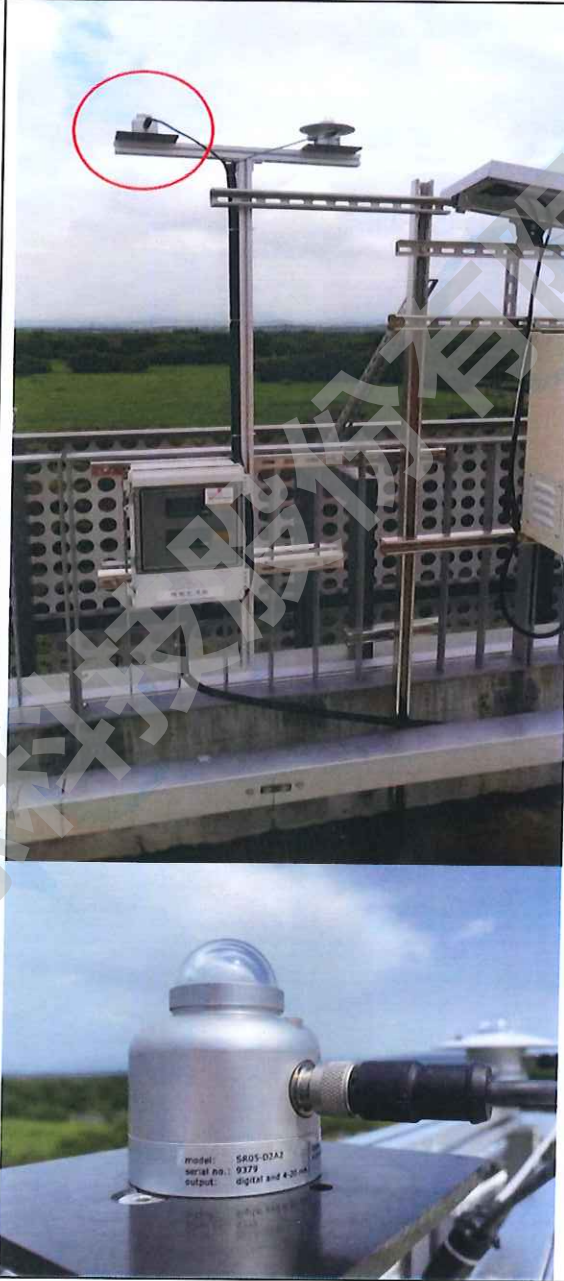
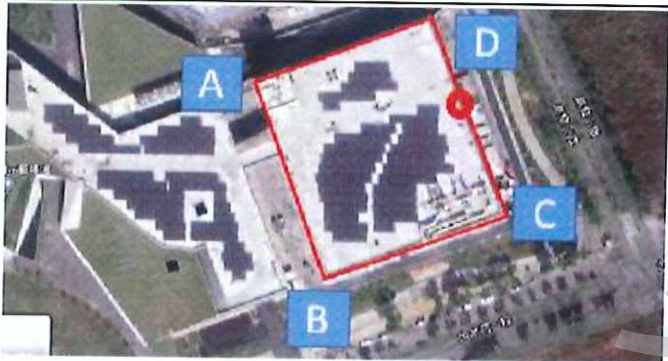
| Table C | |
|---|---|
| Sensor locations | |

| | Pyranometer at the red circle | |

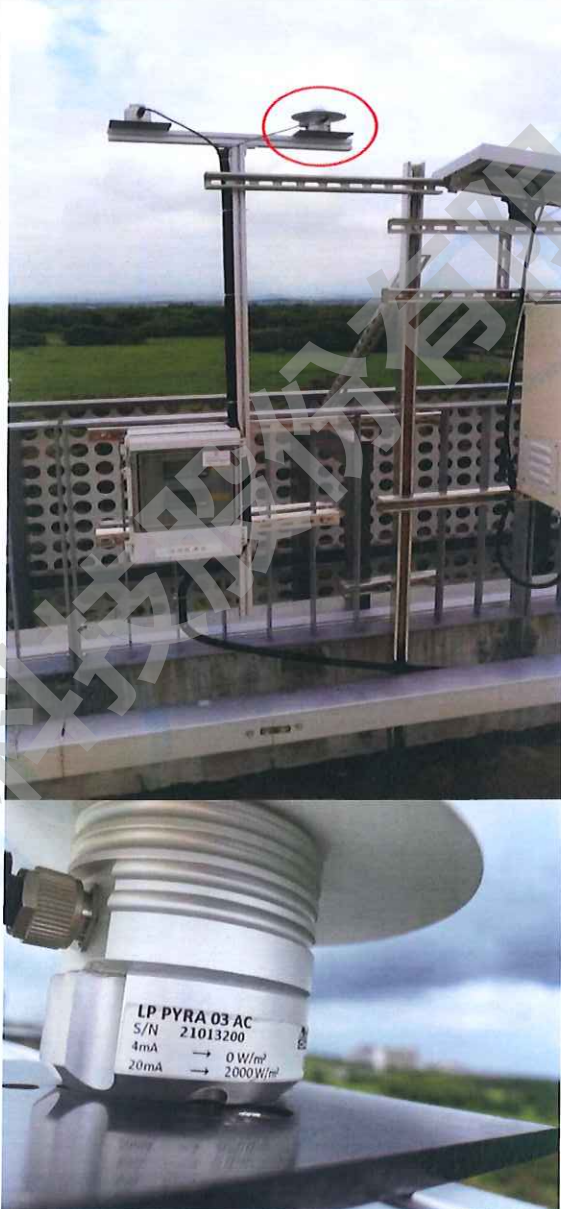
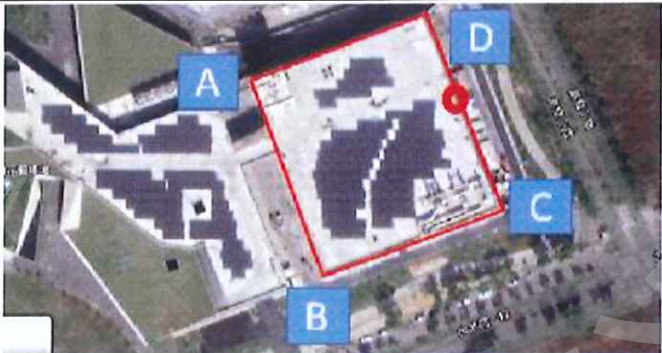
| Table B | |
|---|---|
| Sensor locations | |

| Pyranometer at the red circle | | |

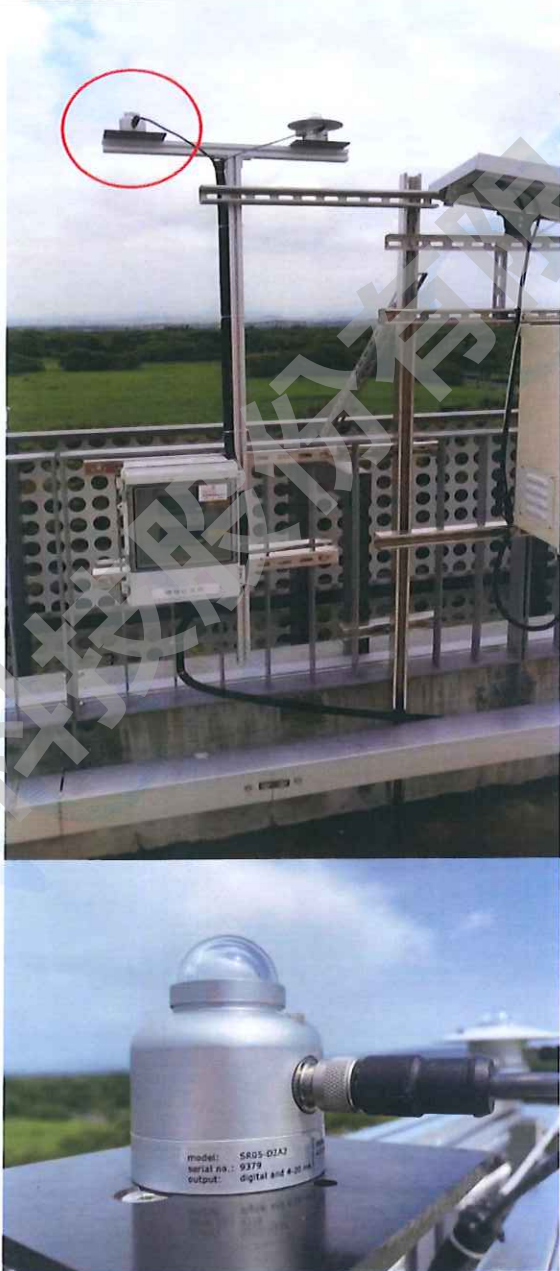
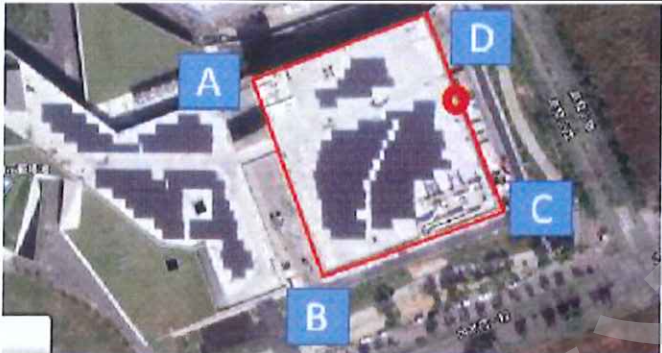
| Table C | |
|---|---|
| Sensor locations | |

| Pyranometer at the red circle | | |

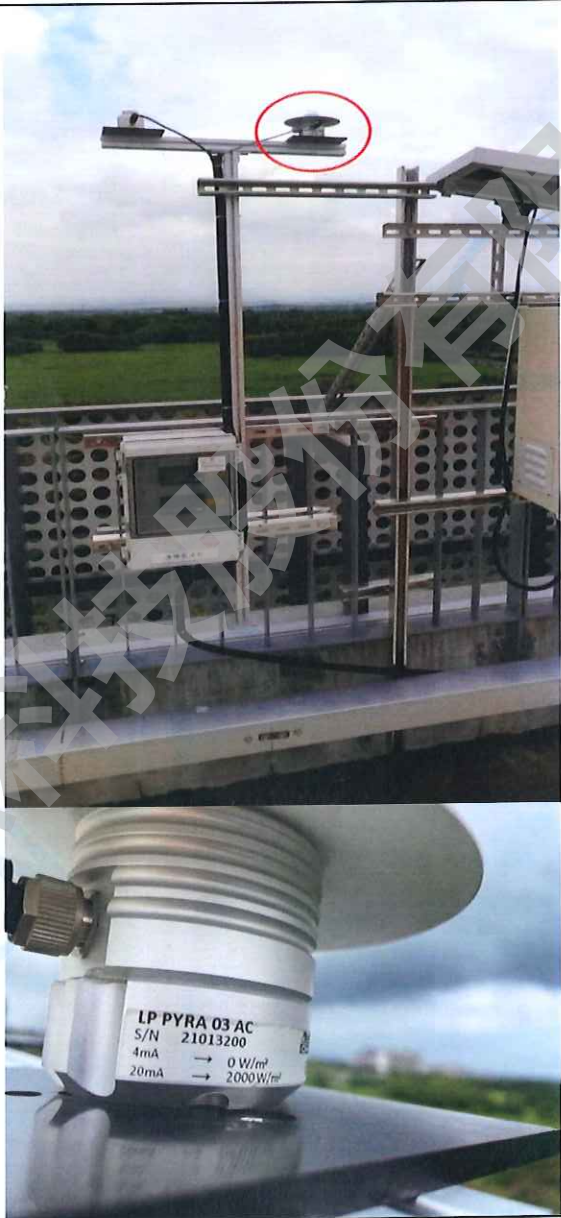
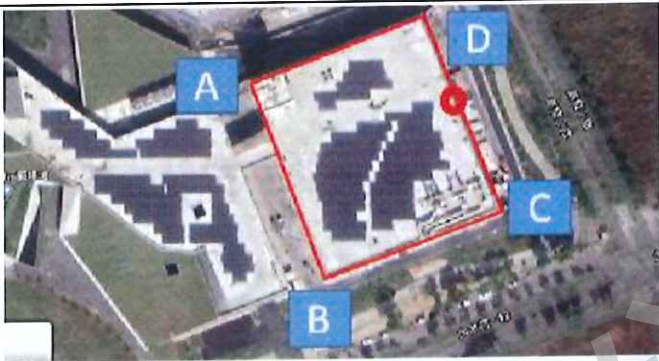
| Table B | |
|---|---|
| Sensor locations | |

| | <p>Pyranometer at the red circle</p> | |

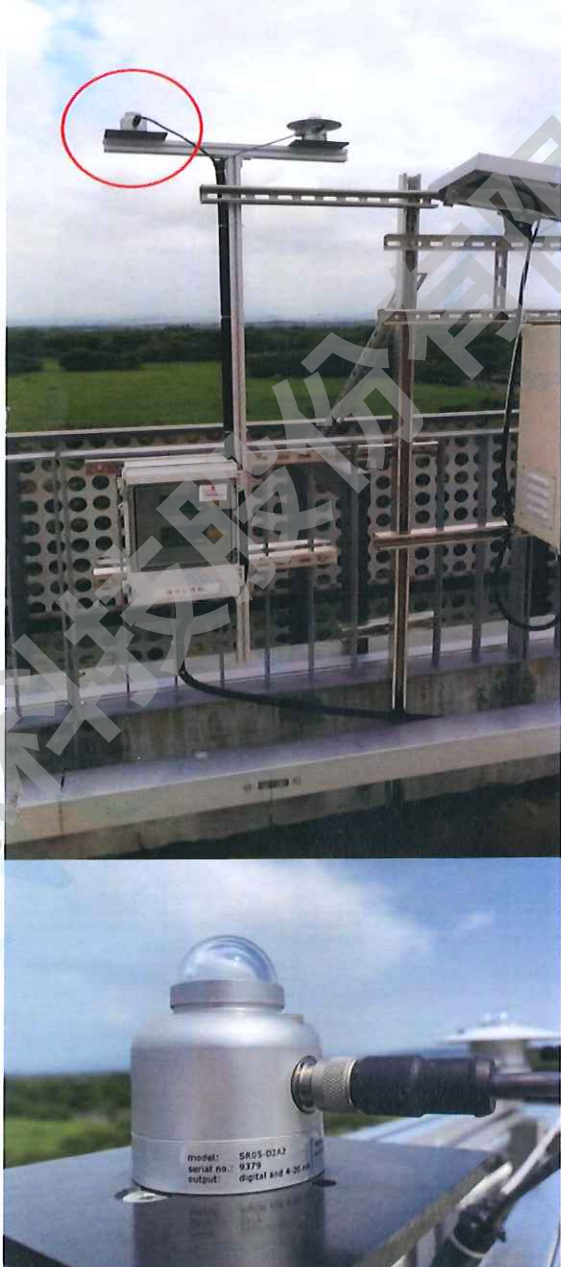
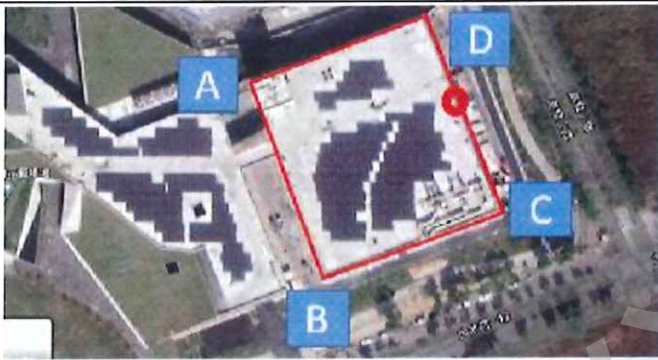
| Table C | |
|---|---|
| Sensor locations | |

| | Pyranometer at the red circle | |
