# Test Report

Report No. : 11055C01031-2-4-02

Service Item : 日照計累積照度比對英文測試報告

Sample name : Pyranometer

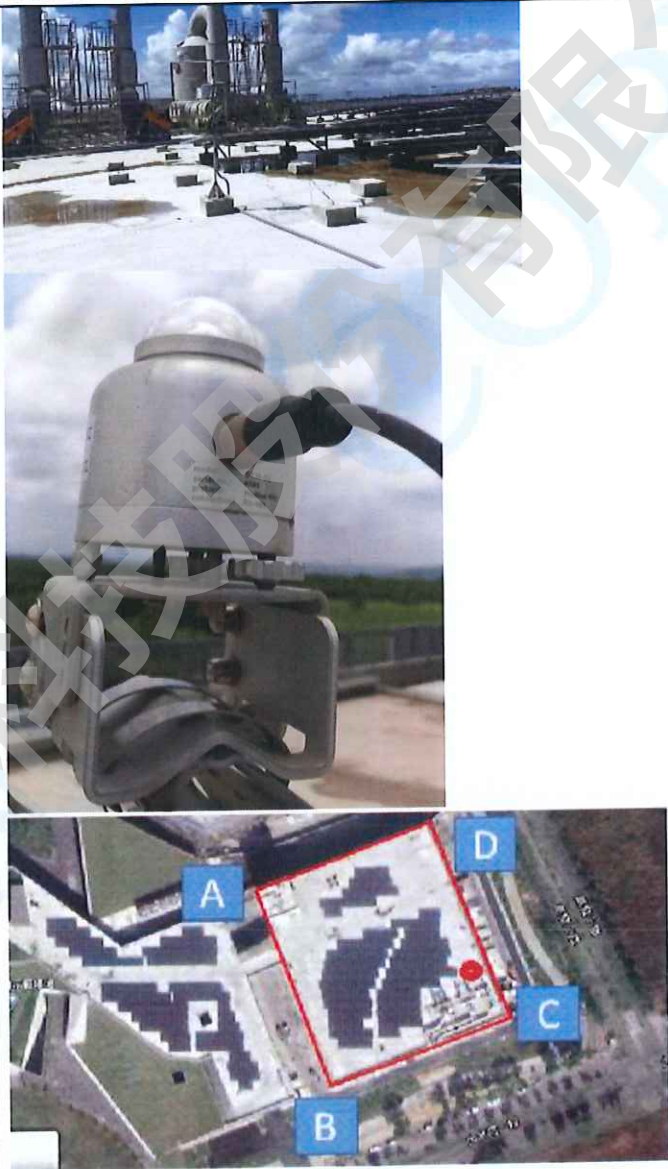
| Table A | | |
|---|---|---|
| Sensor locations | | |
| | Pyranometer at the red circle | |
